Report for 2001SD1941B: Alternative Conservation Practices to Improve Soil and Water Quality

Abstract

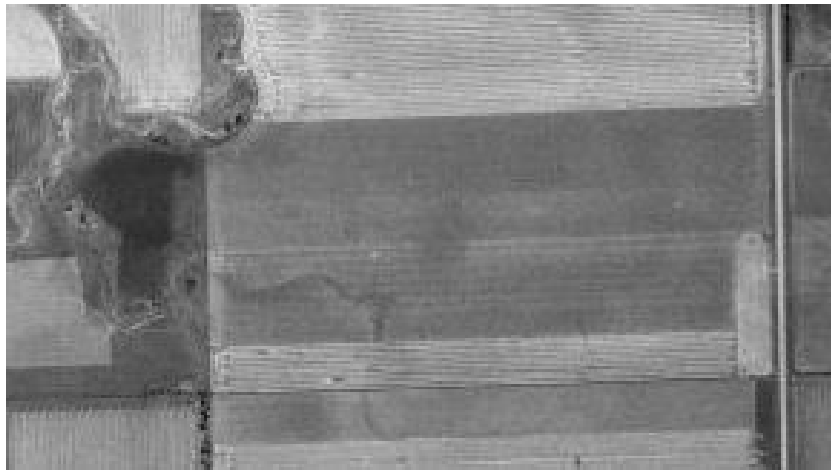
Figure A1 – Watershed with Grass and Tile Waterway.

The watershed with the tile and grass waterway had been recently reshaped, reseeded, and tile installed in 2000. Figure 1 is a photo of the flume and sampler being installed at the outlet of the waterway. A second sampler was installed at this site to collect water quality samples from the tile outflow. Figures A1 and A4 are aerial pictures and topographic maps, respectively, of the watershed area. General soil types were Moody silty clay loam and Houdek clay loam with Davison-Crossplain silt loams in the waterway areas.

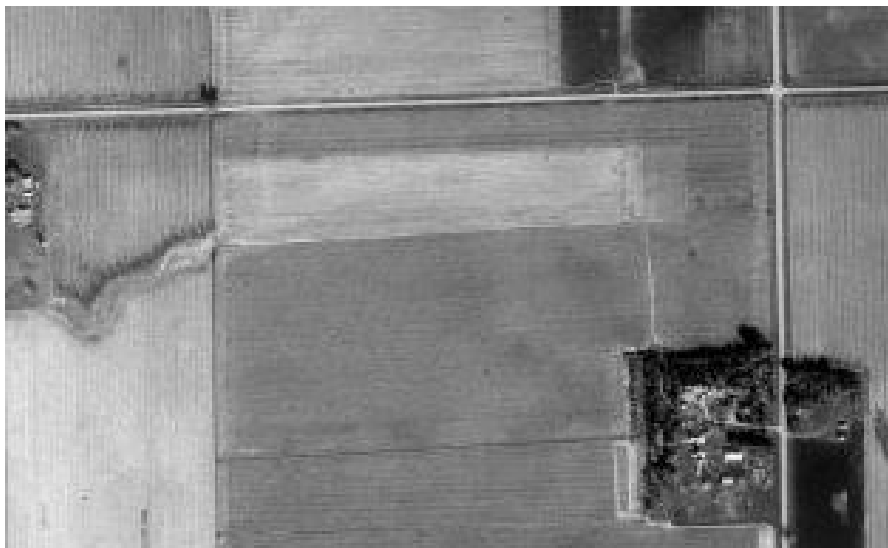
Figure A2 – Watershed with Tile-Only Waterway.

The site having the waterway with tile drainage but no grass had been cropped for many years without any visible erosion in the waterway. The waterway had very flat side slopes with no clearly defined channel. Figure 2 is a picture of the waterway outlet and sampling equipment. Figures A2 and A5 are aerial pictures and topographic maps, respectively, of the watershed area. An established tile line was underneath the waterway. Soils in this watershed were predominantly Moody silty clay loam with some Wakonda-Chancellor silty clay loams.
